Avonmore Associates

Installation of pipe drainage system

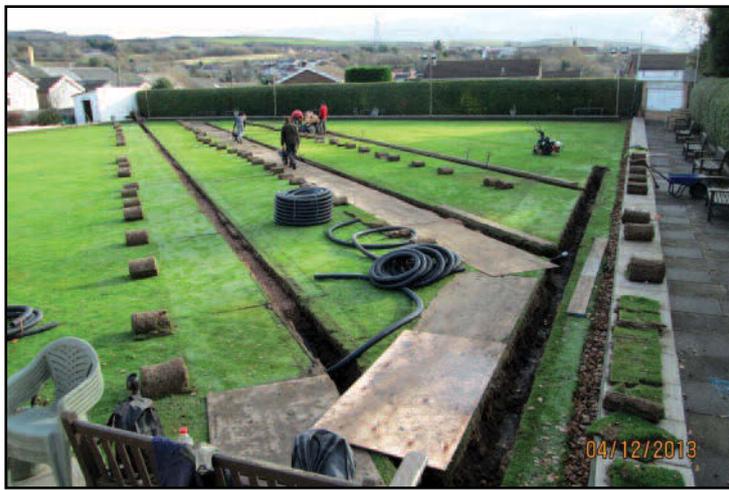
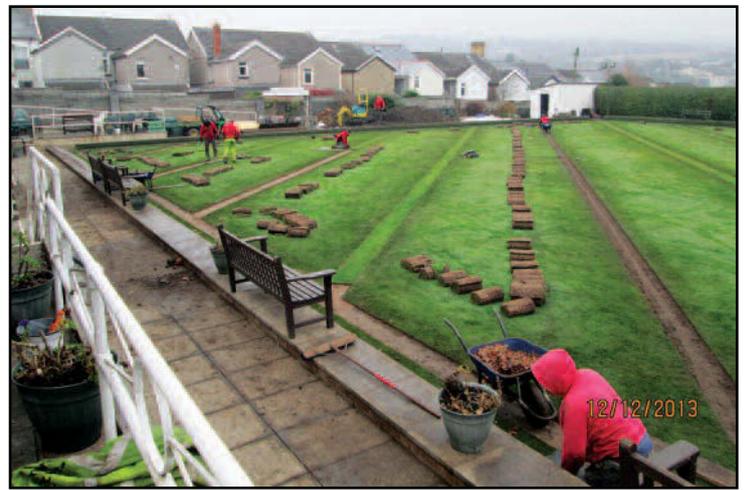
In February 2013, the Club were again in contact with **Avonmore Associates** and a visit was arranged to see what could be done to overcome the constant problem of flooding. After exploratory excavations were carried out it was identified that water movement below ground (capillary action) was as much of a problem as the excessive rainfall. With all the aeration work which had been previously done it was concluded the only way forward would be to install a piped drainage system. Unfortunately this could not be done until Autumn 2013, thus forcing the club & **Avonmore Associates** to battle their way through the 2013 season.

Finally in December 2013 **Avonmore Associates** arrived on site to undertake the installation of the piped drainage system at 4.5m centres across the total area of the green. Still the Mid Glamorganshire terrain would not give in. Large amounts of rock were exposed forcing the necessity to remove approximately double the amount of material, meaning the same had to be replaced (and as anyone who has been to **Merthyr West End Bowling Club**, will know access is limited). Fortunately, with weather on their side and floodlights in place **Avonmore Associates** were able to complete the work within 2 weeks.
